# Project Cabrio

## DRIVE AXLE REPLACEMENT

### The easy way to replace a worn outer CV-joint

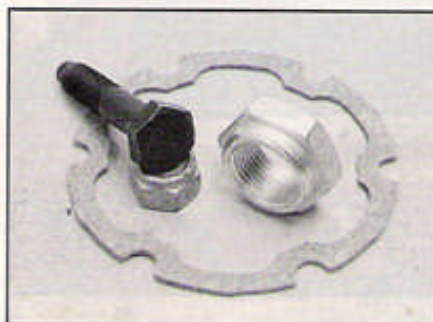
**ABOVE**, extremely sticky (and very icky) CV grease everywhere! This is what you have to look forward to when a CV boot gives way. **RIGHT**, the Volkswagen's inner CV-joint is of a unique design, in that there is recess for a gasket.

From the time we did a major inspection of Project Cabrio (that included the CV boots), until we actually got around to doing it again was, well, too little too late. The driver's side outer CV boot had a major tear, and grease had slung everywhere. Worse yet, plenty of dirt had found its way into the CV itself, thanks in part to the major road construction project it passes through daily.

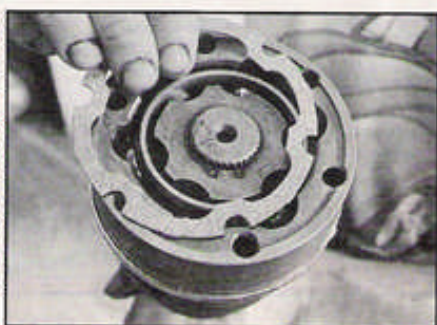
**LEFT**, 1988 and later Cabriolet axles, and all replacement CV-joints, have a larger, 53mm (2.09-inch) step on the face. This larger step could interfere with the wheel bearing's inner circlip on earlier models. Compare the rebuilt axle, and old axle being removed. If a difference is found, the circlip should be updated also.

As for cautionary notes, be aware that the design of the outer CV-joint changed over the years. On 1987 and earlier models, the diameter of the protruding step on the face of the outer CV measured only 50mm (1.97-inch). Beginning in 1988, and on all replacement CV-joints, the diameter of the step increased to 53mm (2.09-inch). Also in 1988, a new circlip (that provided clearance the larger 53mm step) was used to secure the wheel bearing in its housing. On pre-'88 machines, the inner wheel bearing circlip needs to be changed to the later model, if it hasn't already been done in past maintenance work.

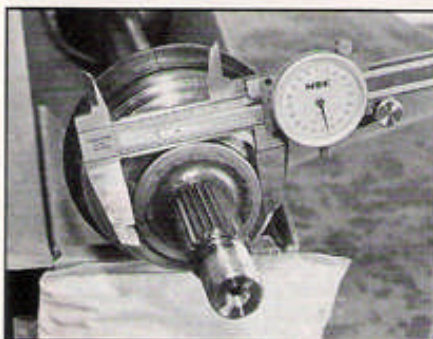
**RIGHT**, with the car on the ground, the axle nut was loosened. It was then placed on jack stands and the tire removed. Diving right in, we cleaned off the inner CV-joint and loosened all six socket head bolts.

For a simple "six-bolt, two-nut, pull-the-pin, pop-the-arm, and swap-it-out" procedure, there are couple of warnings and precautions that need to be observed. Right out of the gate, the main axle shaft nut needs to be broken loose, and torqued, while all four tires are on the ground. Do not attempt these two procedures while the car is on a jack stand, as the axle nut is torqued to 177 ft.-lbs., and that much force could pull a car off jack stands! The other major warning is, when the outboard CV-joint is removed from the car, the front wheel bearing-hub assembly is no longer securely held together, and the bearing can be easily damaged if the tire is reattached and the VW moved.

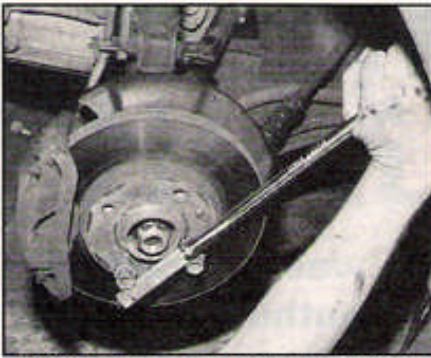
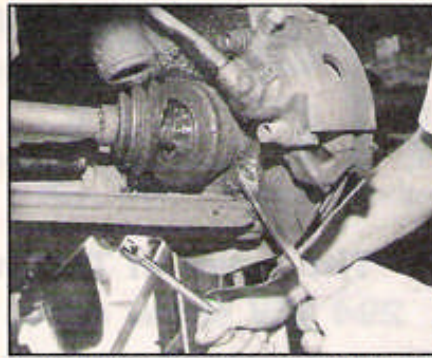
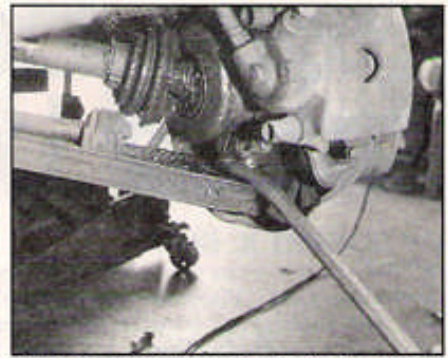
**ABOVE LEFT**, to get at each inner CV-joint bolt, we rotated the axle assembly using a bar wedged between two lug bolts that were temporarily installed. We recommend that one or two bolt(s) be left in the CV to support the axle assembly. **ABOVE CENTER**, in order to pull the strut away from the axle, the lower ball joint clamping bolt was removed. **ABOVE RIGHT**, a pry-bar (or small crow-bar) may be necessary to separate the lower arm from the bearing housing. Note: the clamping bolt must be removed completely.

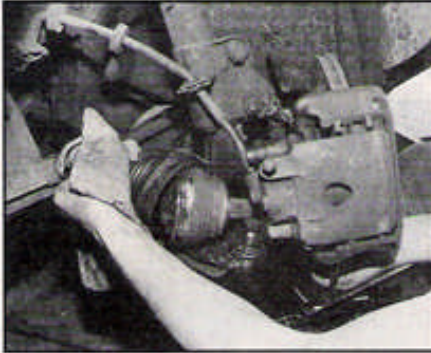
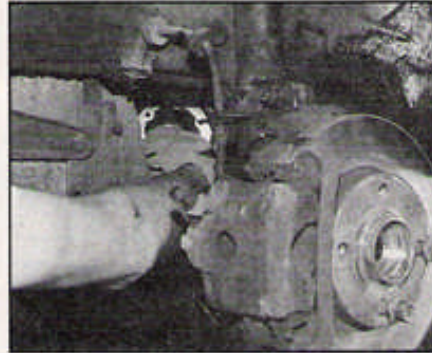
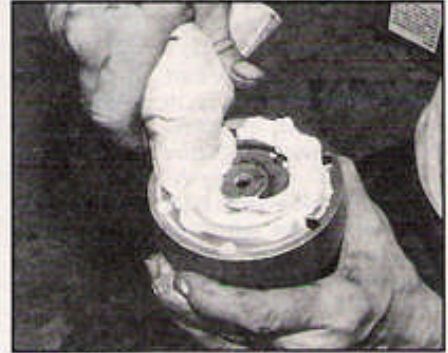
**ABOVE LEFT**, the axle nut was fully removed, and the outer CV-joint slipped out of the hub. Actually, it was more like pounded out, as the splines were very stuck in the hub. Note the steering wheel was turned to help pull the axle out of the hub. **ABOVE CENTER**, the axle assembly was then completely removed, and the cleaning process began. We used spray contact cleaner to clean each bolt hole in the inner CV flange. **ABOVE RIGHT**, let the fun begin! The remanufactured axle assembly from Aragon came with the CV grease need to pack the inner CV-joint. The outer CV was fully packed at the factory and sealed with a new CV boot.

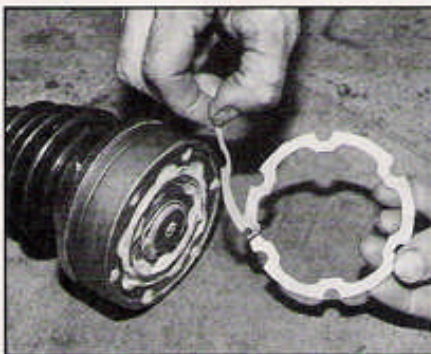
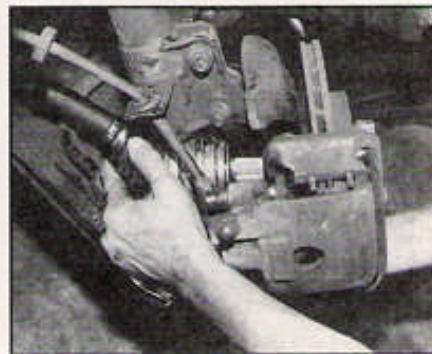
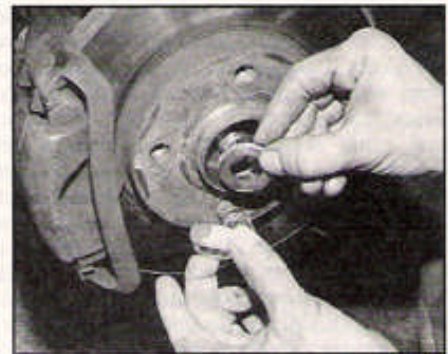
**ABOVE LEFT**, once the inner CV was fully packed with grease, the boot was turned on the axle to align the bolt holes with the CV-joint. The CV surface was then cleaned and the self-adhesive, factory gasket installed. **ABOVE CENTER**, all six inner CV-joint bolts were positioned in the CV, and the axle installed. Once supported on the inside, the outer CV was inserted into the hub. A very light amount of anti-seize compound was used on the six inner CV bolts, and on the splines of the new outer CV-joint. **ABOVE RIGHT**, the axle washer and new VW axle nut was installed finger tight at this time to insure it stays put.

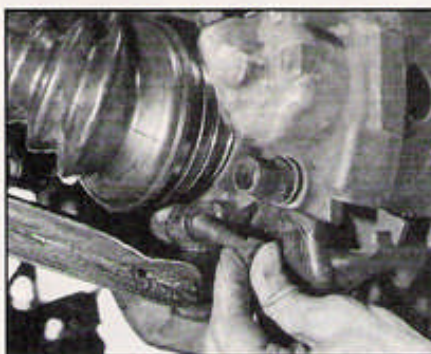
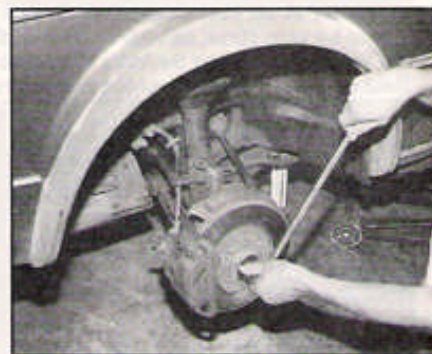
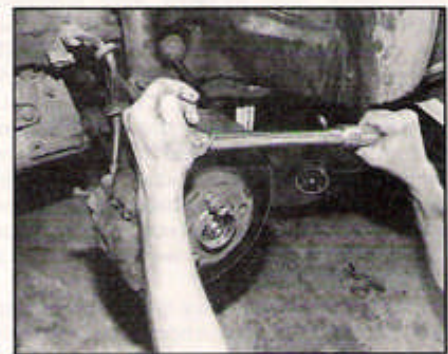
**ABOVE LEFT**, with the drive axle in position and safely supported, the strut assembly and lower control arm were reunited. The new ball joint clamping bolt and nylock nut purchased at the VW dealer were installed and torqued to 37 ft.-lbs. **ABOVE CENTER**, the inner CV bolts are then snugged, followed by the large axle nut. **ABOVE RIGHT**, we torqued the inner CV-joint bolts to the recommended 33 ft.-lbs., replaced the tire, dropped the VW on all fours, and finished up by torquing the axle nut to 177 ft.-lbs.

Other things to be aware of include the bolt and nylock nut that secures the strut/wheel bearing housing to the lower A-arm are of a high, "10.9" grade. Volkswagen recommends this bolt and its nut be replaced any time it is removed. Same goes for the axle shaft nut — get a new one each time it is removed (particularly with a new outer CV). And, in closing, some food for thought. CV grease is like a magnet is to metal, it will jump out and stick to anything that comes remotely close to it. It also attracts dirt and grime faster than anything else known to man, and the last thing your CV needs is dirt in the grease. Take your time, keep it clean, and let's get to work. ●
